Propeller loss on a Sonex

By Robert E. Barber

Builder/Pilot of Sexy Hexy (N157SX)

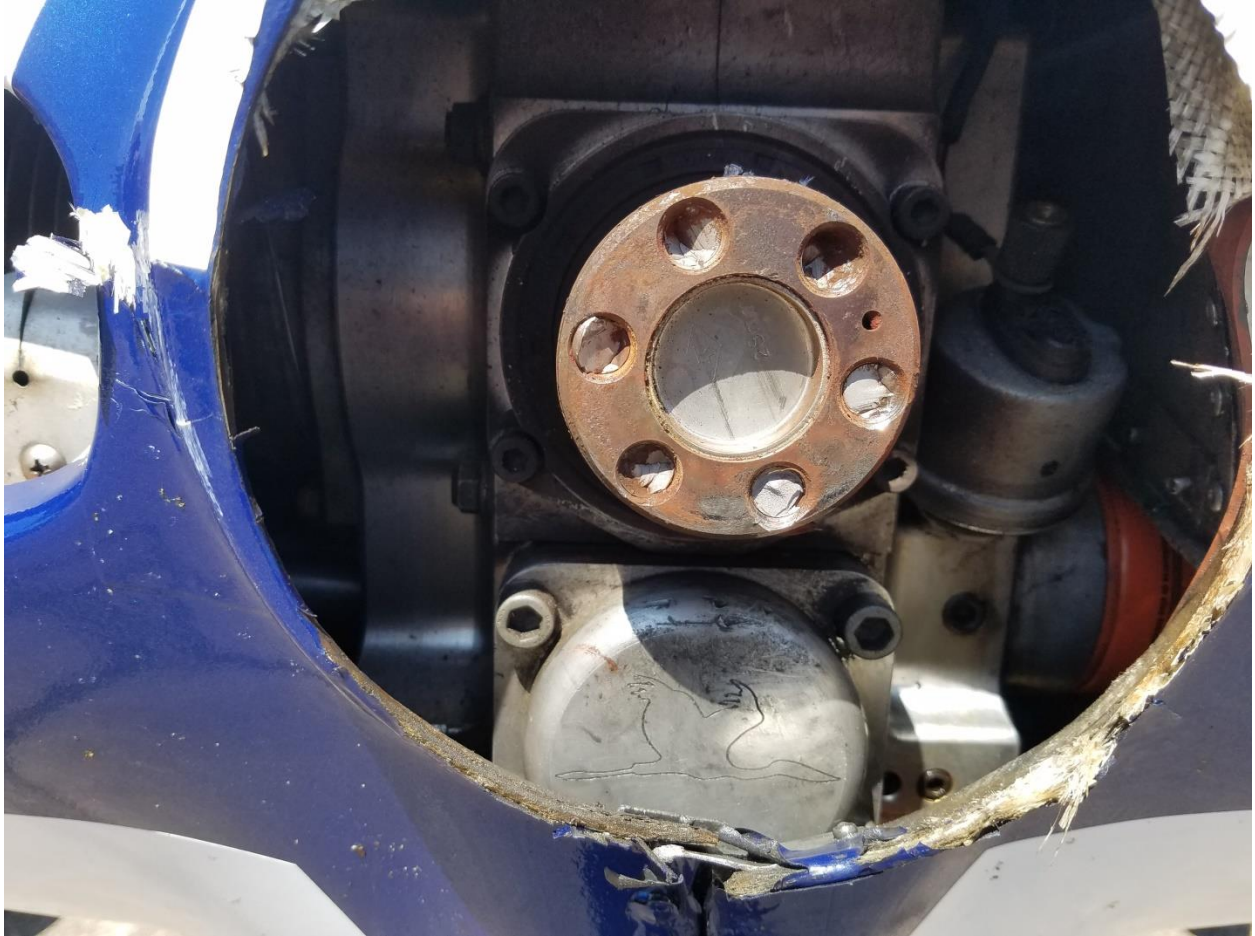
Figure 1. Note the missing prop hub and the fatigued screws still in the crankshaft.

The Socket Head Cap Screws had fatigued and failed. Note the rust on the screw remains in the picture. This has been going on for some time. I had no idea it was failing. The cap screws were factory installed and wire tied, and could not tell they were failing. The cowl was mangled, and the prognosis was not a quick fix. I decided to haul it home, and rented a 20' Uhaul truck to do it. A disassembled Sonex will fit, but just barely!

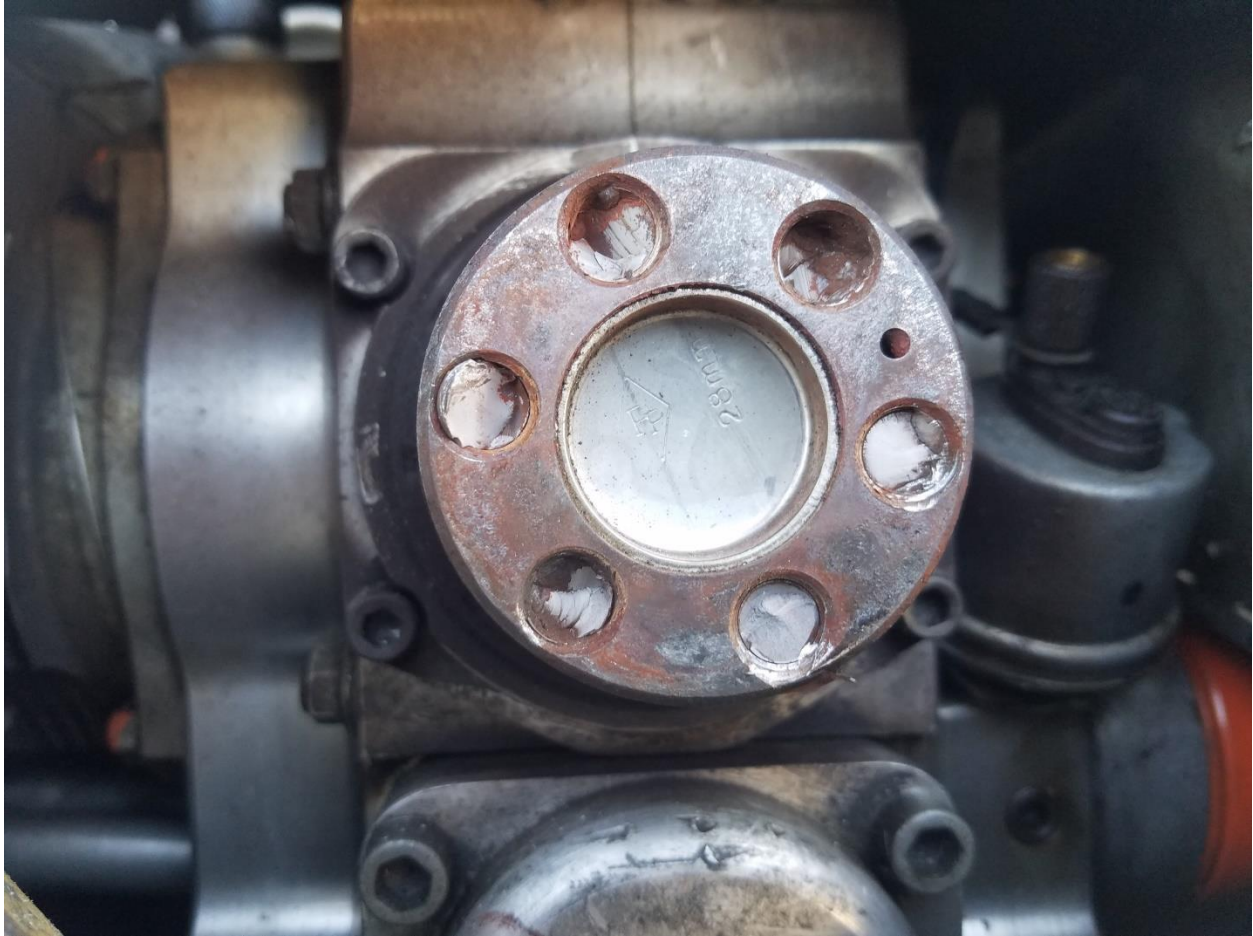
The post inspection revealed that the prop really smacked the cowl pretty hard, as it was hard to remove and some of the internal baffling was smashed. The screw remains were easily removed. After measuring the runout I found no damage or anything else. The screws came straight out with a left handed drill bit. There was no Loctite on them. It was a bit of a surprise, and apparently only occurs on the first batches of engines where they used safety wire. I also noted that there is no fretting on the face of the crankshaft, indicating that the failure was one where the prop flange did not slide around at all on the crankshaft, so the screws were holding tight up to the last few rotations that caused the vibrations.

Figure 3. A close-up of the failed screws. Some cleanup of the rust on the face so I could measure with confidence was done. There was no fretting on the face, but some impact wear near the last screw to fail (bottom right).

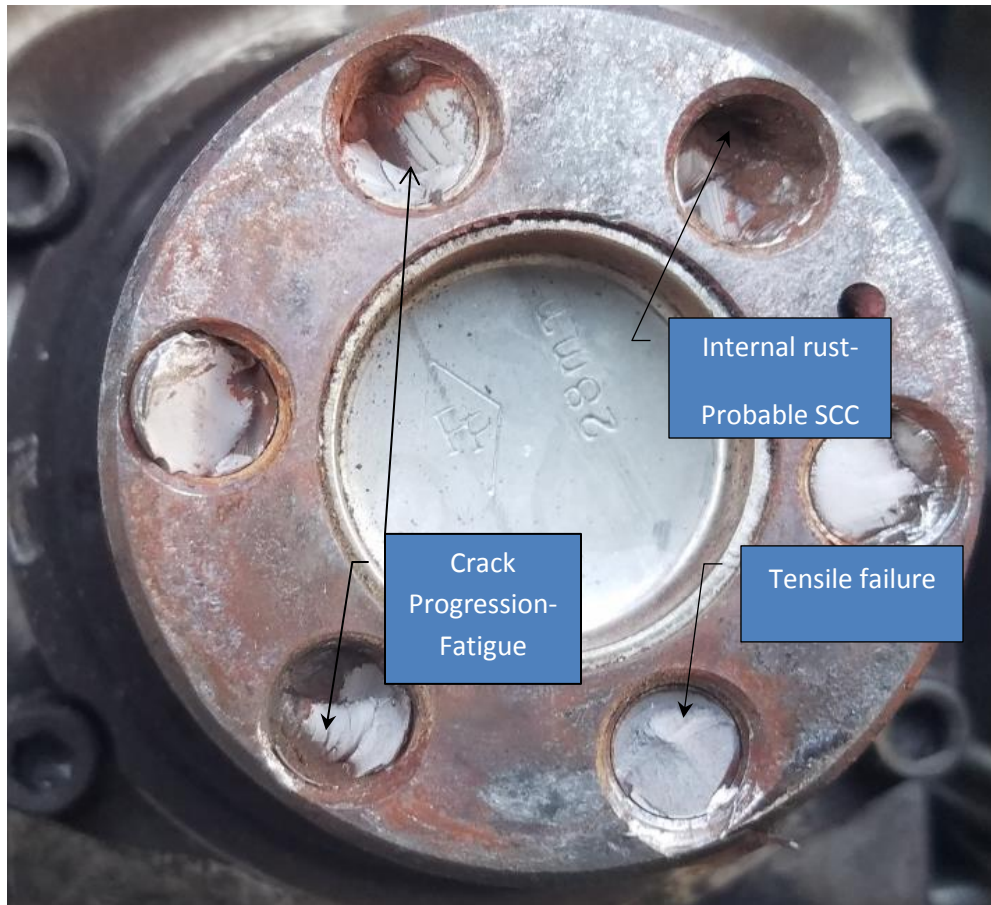
I am of the opinion that the fatigue was caused after some stress corrosion cracking (SCC) initiated the failure, eventually reducing the cross sectional area, and therefore increasing the stress to the point where fatigue can take over. One screw failed in tension as can be seen in Figure 4. The remaining show clear signs of internal rust and subsequent fatigue, which indicates the likely path to failure. After a bit of research, it was found that SCC can occur in high strength steel with the right conditions are there; appropriate stress levels, an appropriate corrosive environment, and a stress riser.

The stress level can only be speculated since it was done at the factory, but if they used the currently specified torque (30 ft-lbs), it would have been roughly $\frac{1}{4}$ of the proof test limit of 16800 lbs at 4800 lbs of clamping force per screw. This would have produced an adequate stress of 49 ksi. The corrosion was evident, but not clear what the source of corrosion was. Just moisture? I can only speculate here. The stress riser? The threads were rolled, and should have been the best choice for strength and fatigue resistance, but that does not eliminate any chance of stress risers at the bottom (minor diameter) of the threads.

Figure 4. Close up of screw fracture surfaces.

How will I address this problem?: Replace the screws every 300 hours. Also, always try to be abeam the numbers when the prop is scheduled to fly off!
