Synopsis of an Engine Failure

Generation 1 Jabiru 3300A, S/N 299

Sonex #271, N157SX

May 5, 2019

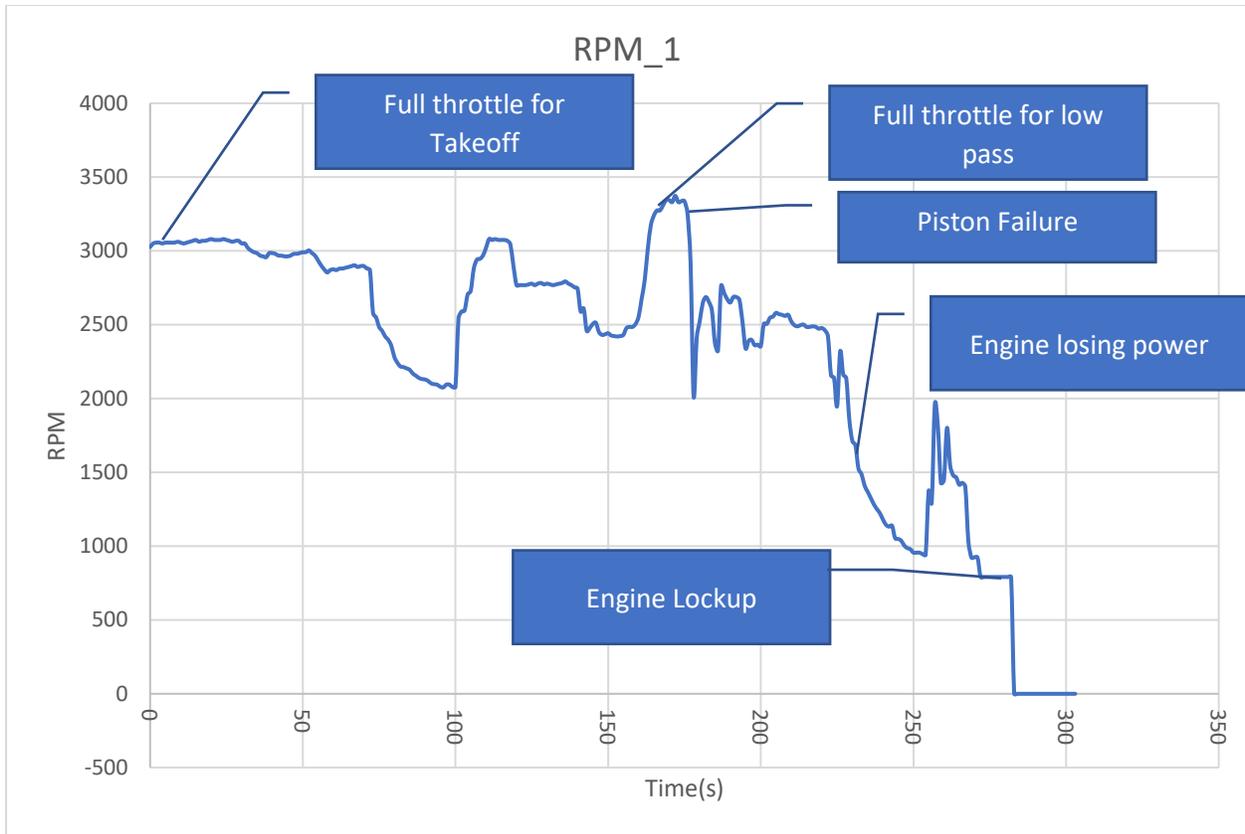
Figure 1. RPM history, from takeoff to landing. Max RPM 3330.

As can be seen in Figure 1, the entire flight lasted only about 5 minutes. The drop in RPM associated with the failure can be clearly seen.

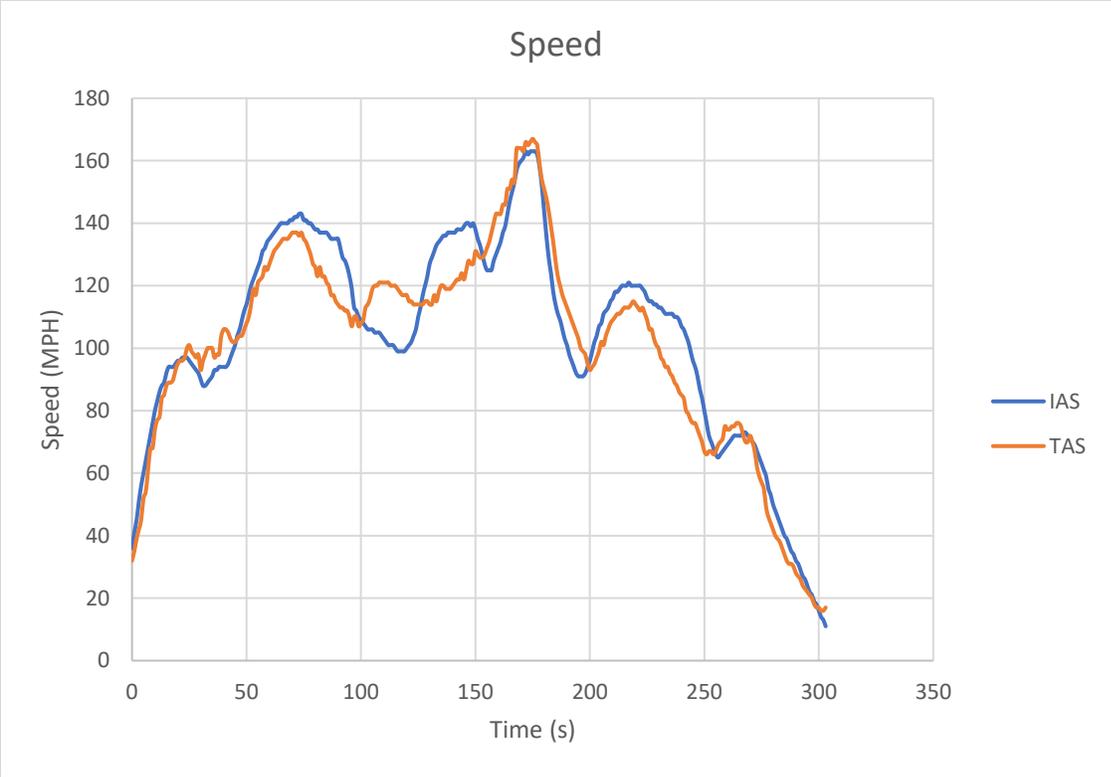
In Figure 2, the reduction in speed corresponds to climb out to pattern altitude.

Figure 2. Speed vs time.

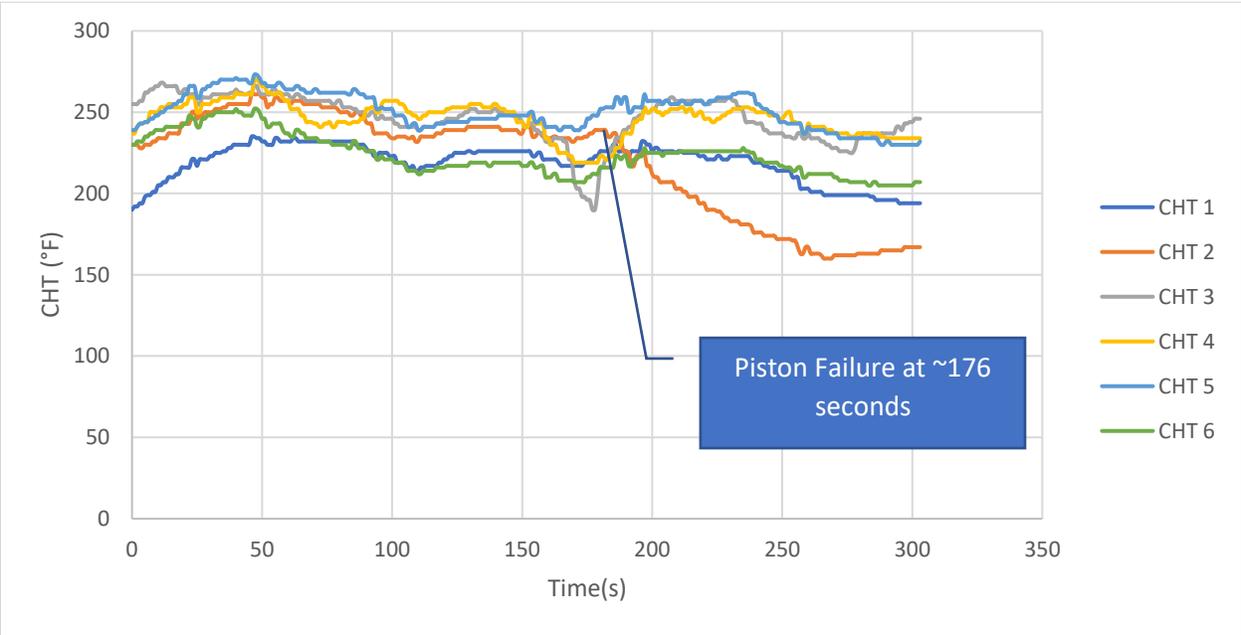
Figure 3 shows the CHT for all cylinders. Note the CHT for #2 dropping after the failure, despite the rod flailing around in the cylinder.

Figure 3. CHT vs Time

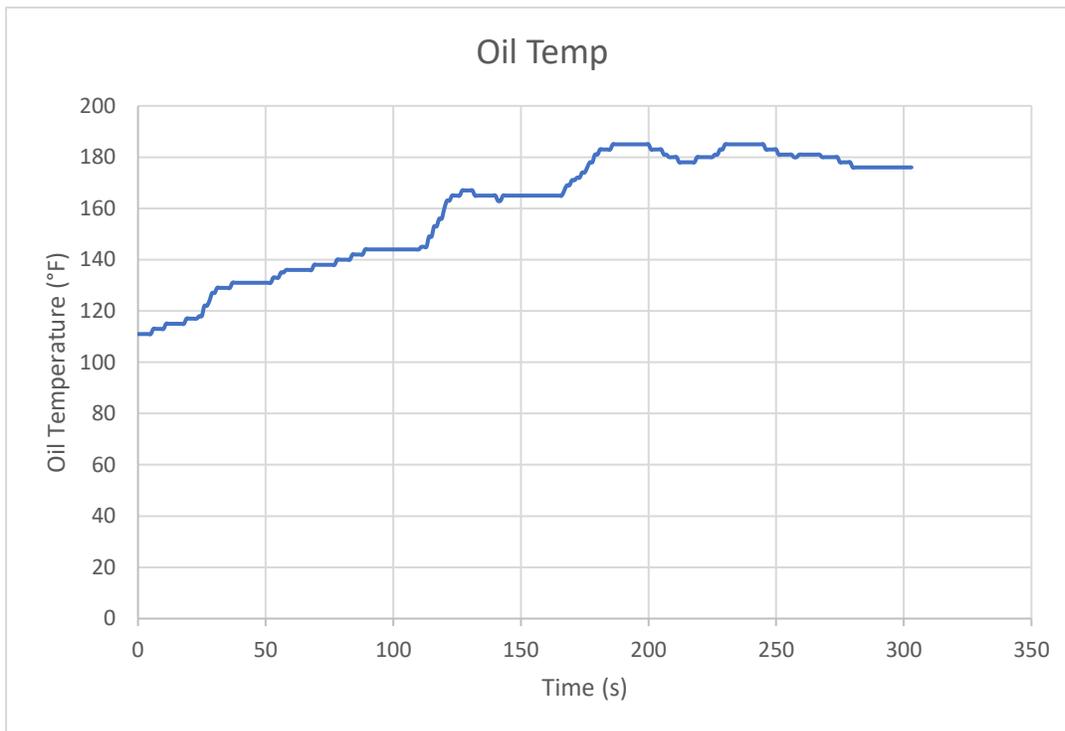
Figure 4 shows an immediate rise in oil temperature post failure, but the temperature is not excessive.

Figure 4. Oil Temperature vs Time. Max Oil temperature was 185°F.

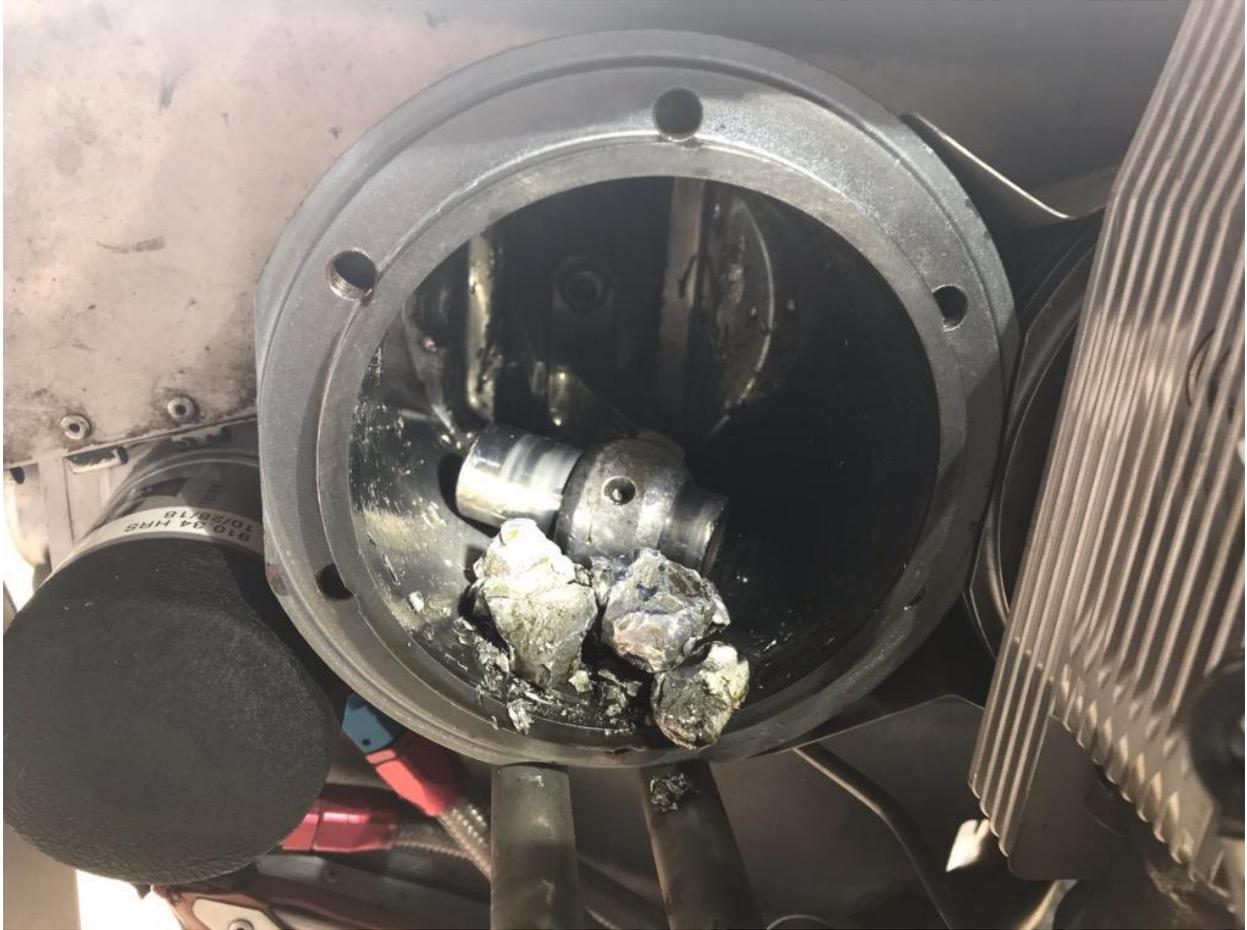
Figure 5. #2 Head removed. The piston is mostly missing, but the rod, wrist pin, and everything else is still there.

In scenario 2, the new piston could have had a casting flaw in it. It was relatively new (less than 50 hours). Though rare, it does happen. A small precipitate, grain of sand, etc. at the correct place with enough cycles would cause this. There would likely be no evidence unless the origination point could be found among the battered aluminum in the crank case.

Since the valves appear intact (I believe the head is salvageable), I don't believe scenario 1 is likely. Scenario 3 is also unlikely, since there is no evidence to support it. No scratches or galling in the cylinder. Scenario 2 I feel is most likely, but there is no evidence to support it, as the piston has been reduced to granola size bits.

The damage includes the engine case, the crankshaft, the rod, wrist pin, at least two lifters, the camshaft, and possibly the head. I am currently working toward buying a new Gen 4, since the parts for a rebuild are getting scarce. The case, lifters, and camshaft are no longer made. I hate this, as the time and money spent rebuilding the engine is now for a meager 50 hours. And it ran so sweet.

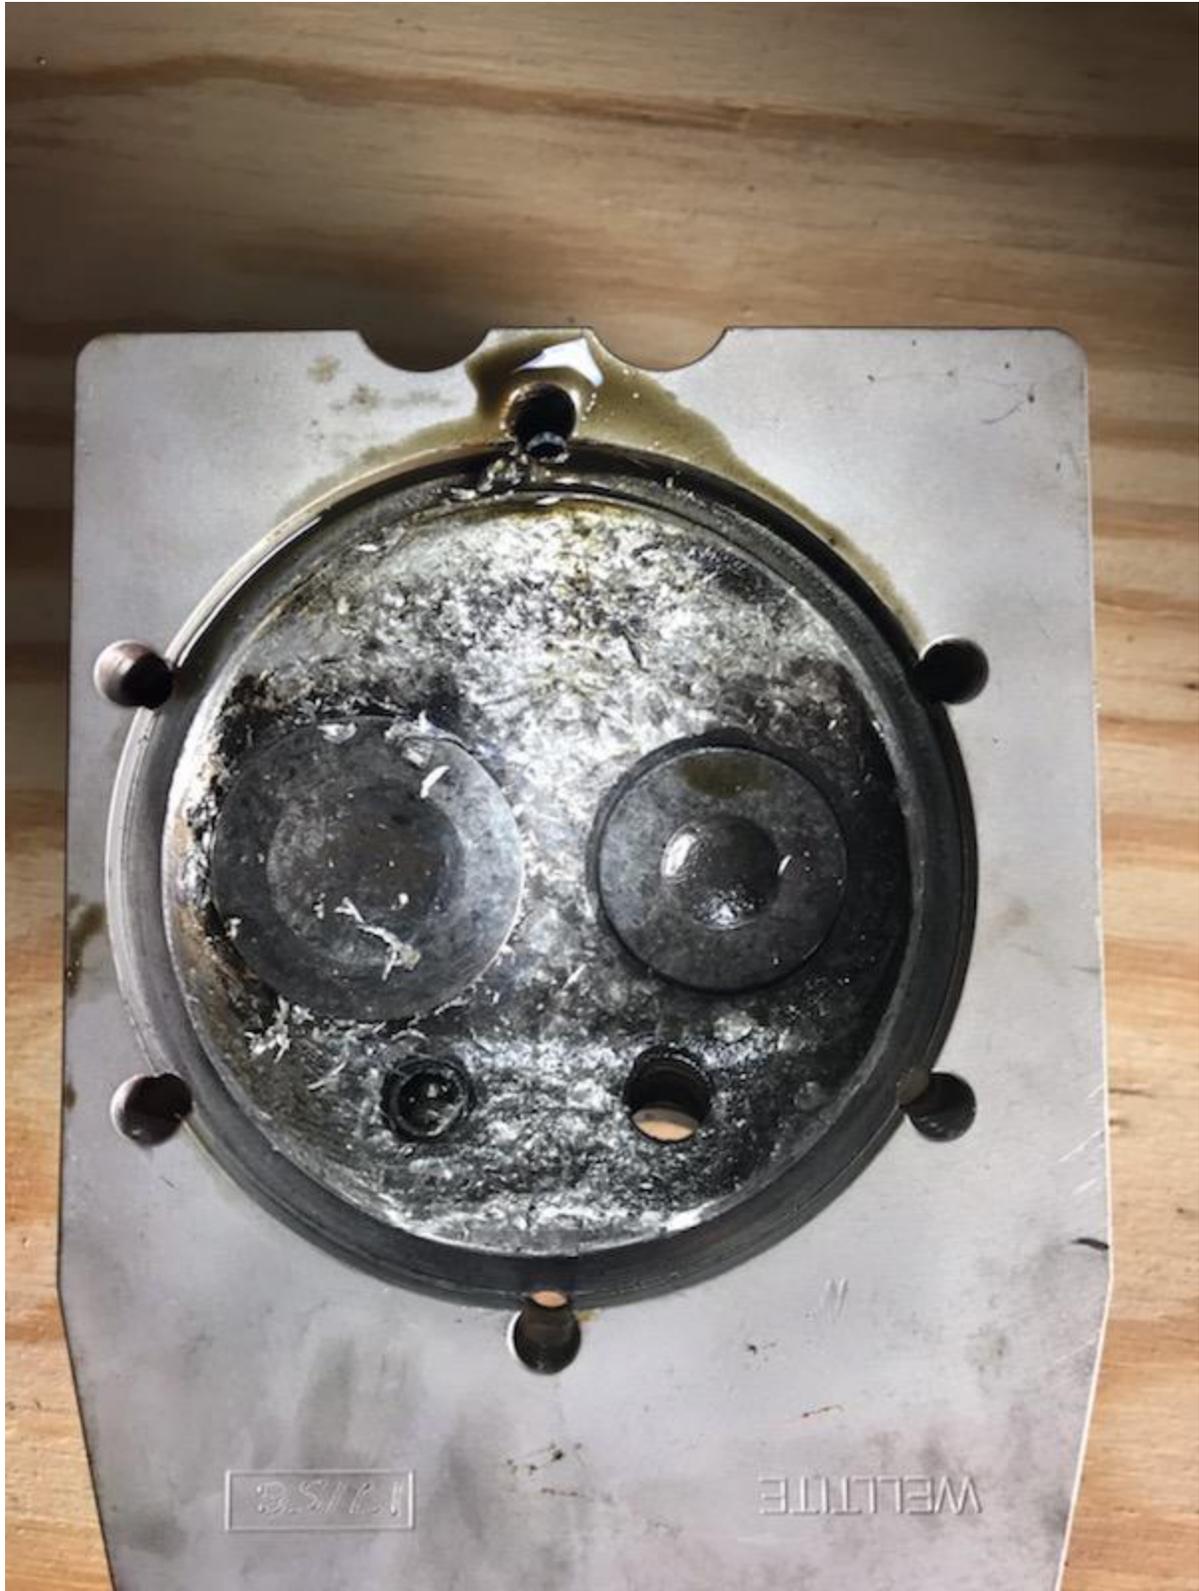
Figure 6. Head (cylinder face). Both valves remain. Exhaust valve has slight bend.

In scenario 1, the valve stuck open and impacted the piston. The valve does not have any evidence that this occurred, other than being slightly bent, which could have happened as the rod reduced the piston to aluminum granola. Evidence of this would be usually a broke valve of at least severely bent.

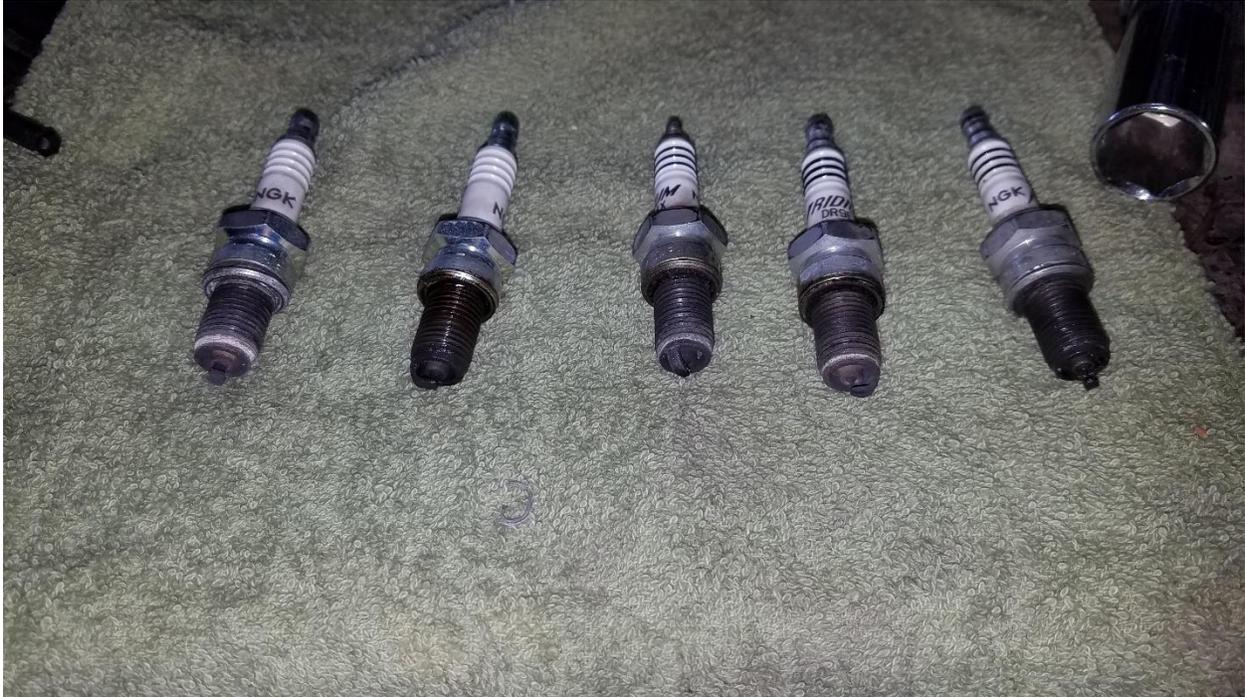
Figure 7. Spark plugs examined looking for signs of detonation. Cylinders were also borescoped for evidence, but none was found. Note that all plugs are black, indicating a rich mixture.

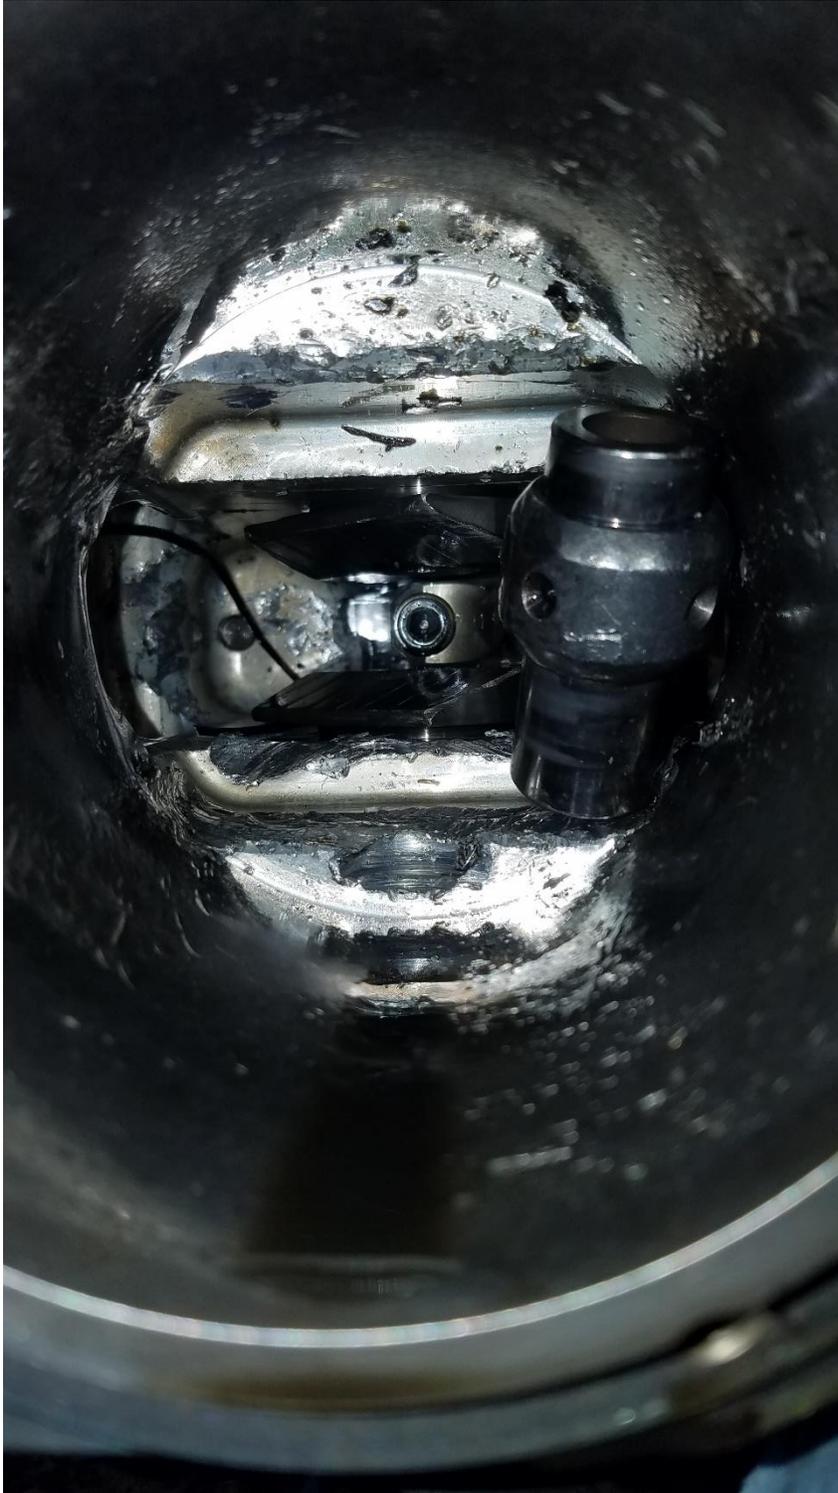
Figure 8. Inside the cylinder. Not including the damage caused by the rod/wrist pin beating against the cylinder walls, the cylinder looks actually quite good.

In Scenarios 3, if the piston/rings were deprived of oil and stuck, the wrist pin would simply pull the bottom off of the piston. Evidence of aluminum sticking to the cylinder or scratches on the cylinder from the rings would be evident. There is no obvious signs of either, but they could be buried in the region pummeled by the rod/wrist pin.

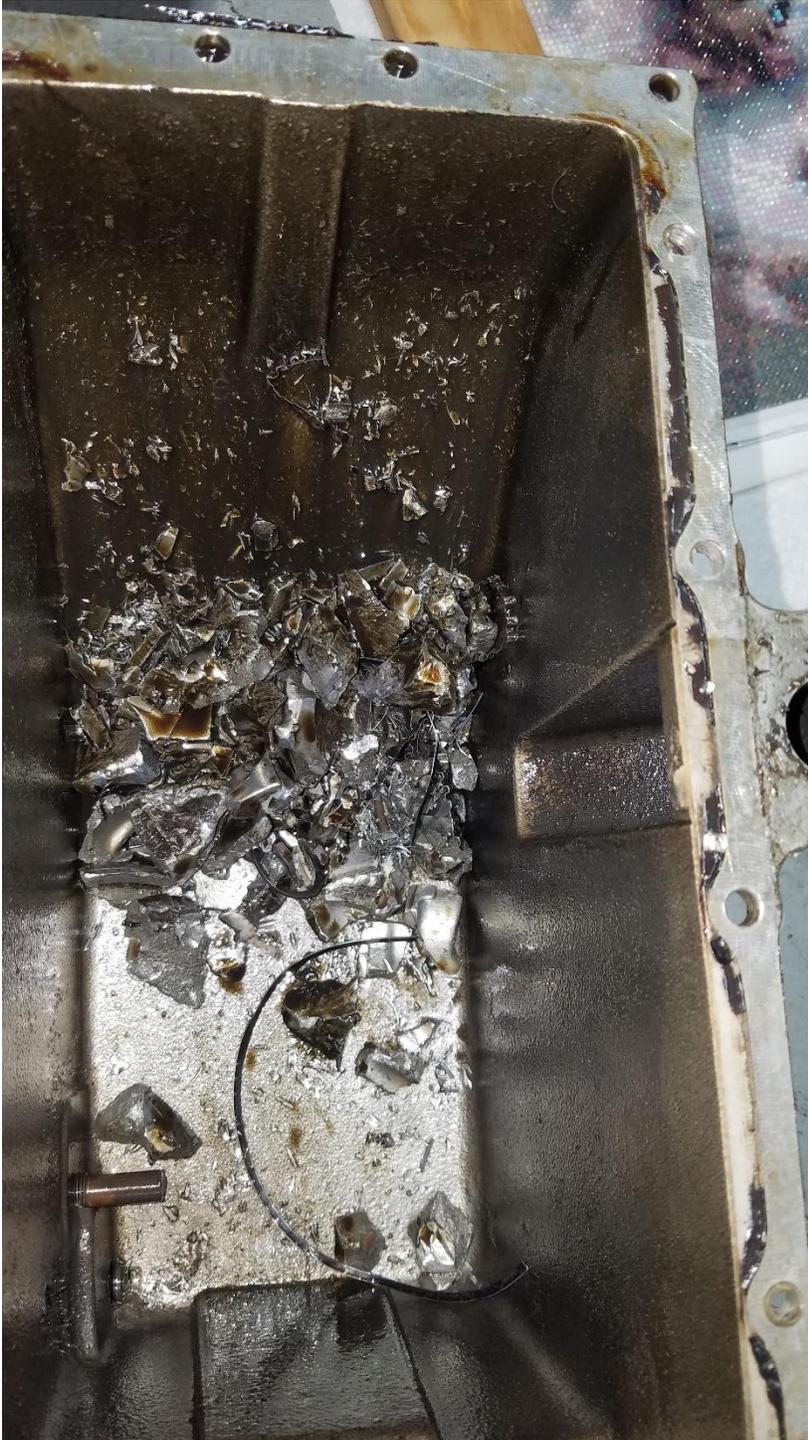
Figure 9. The rest of the piston, rings, and circlips were found in the sump.

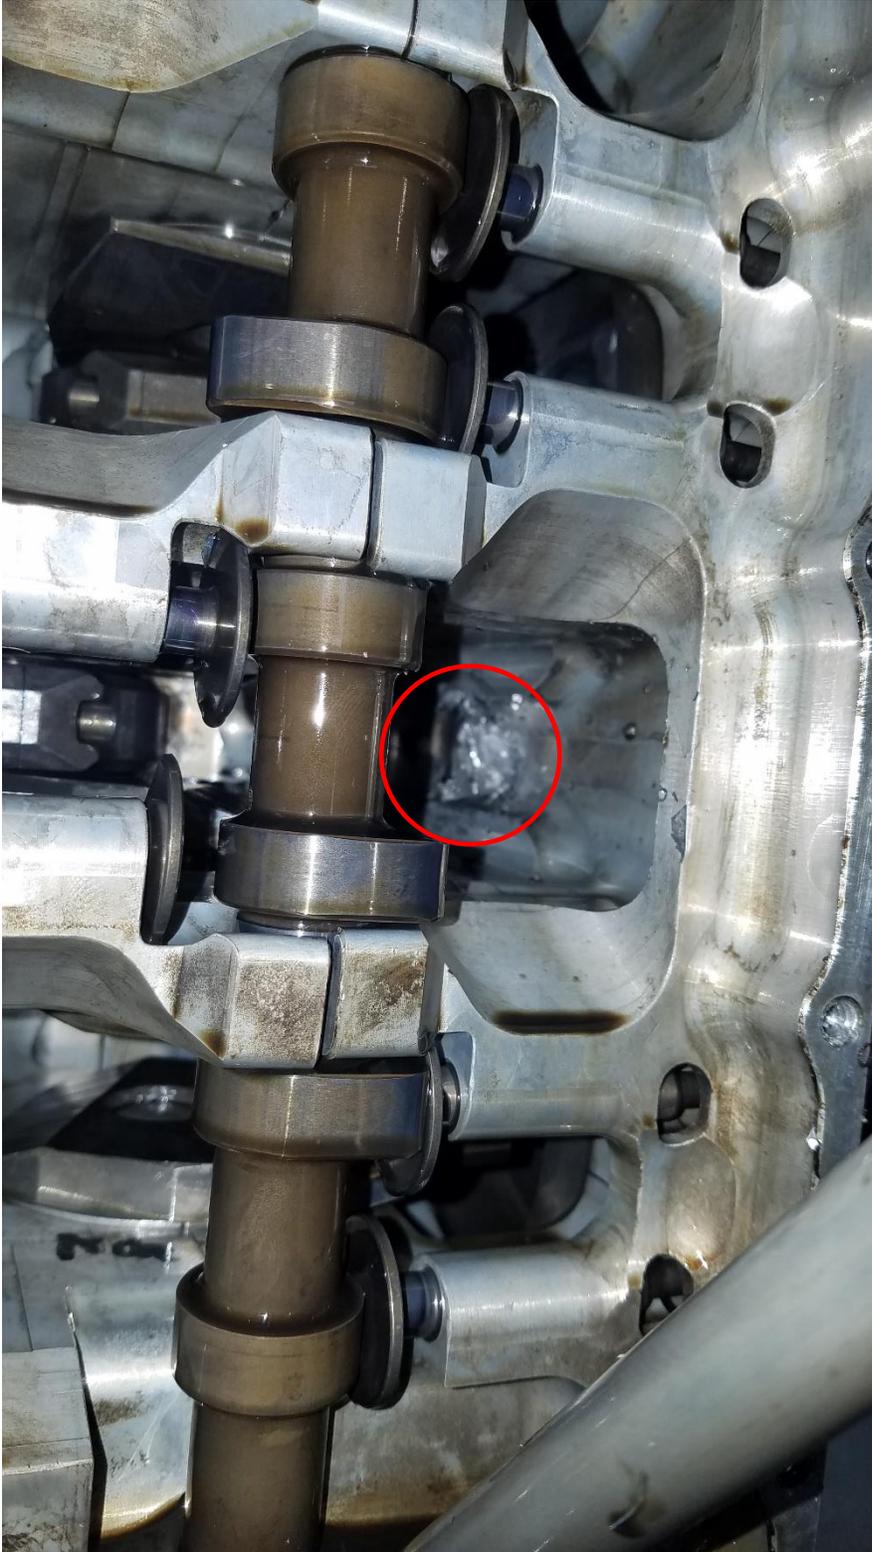
Figure 10. Bottom of the crank case. Notice the deformation evident by the separation of the case half beneath the cam. Also note the chunk of piston shoved through the wall of the case between cylinders 1 and 3.

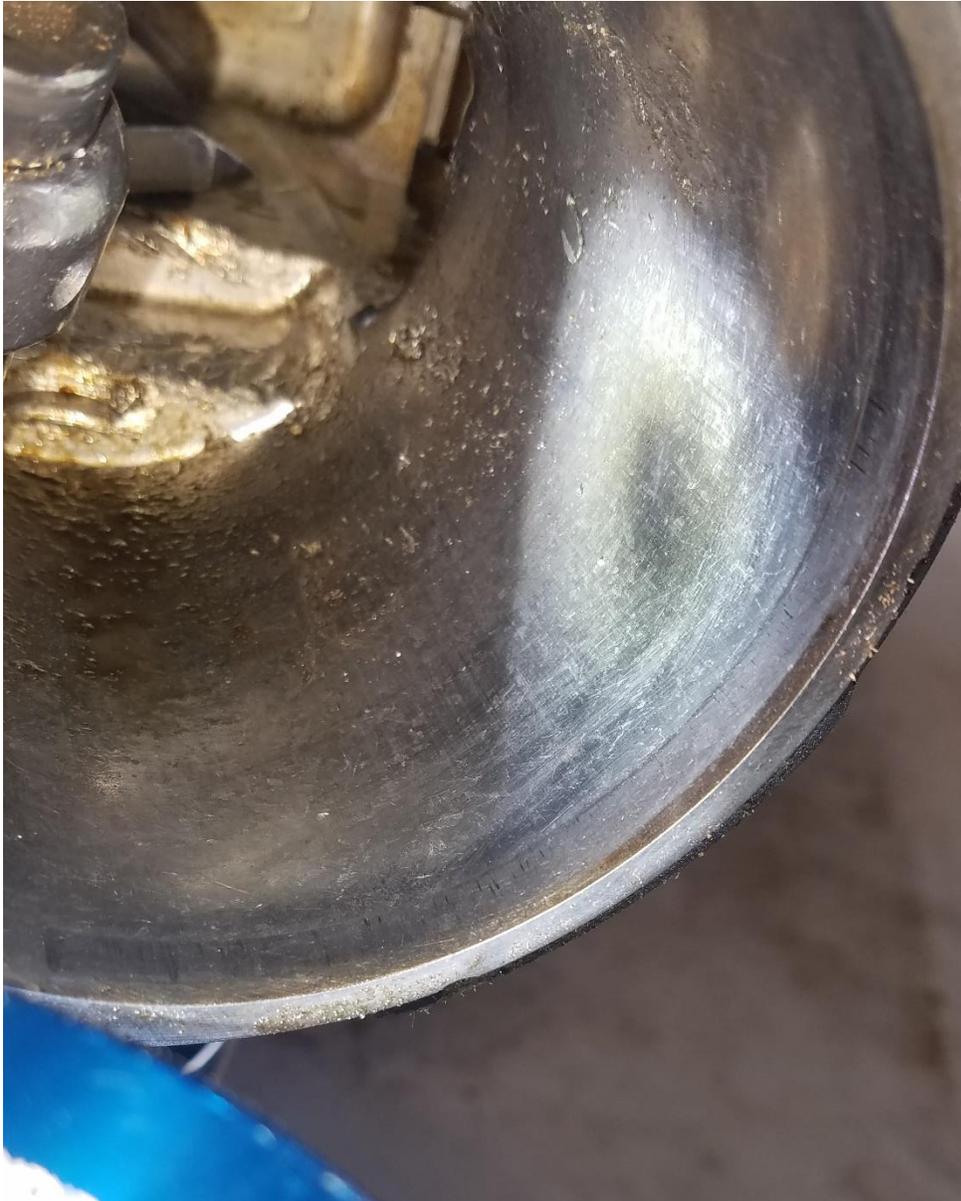
Figure 11. Picture of cylinder wall. Aside from the damage caused by the rod crushing the piston, the cylinder has no scratches, scoring or other damage.
