## Synopsis of an Engine Failure (again)

Generation 4 Jabiru 3300L, S/N33L 146

Sonex #271, N157SX

Robert E. Barber

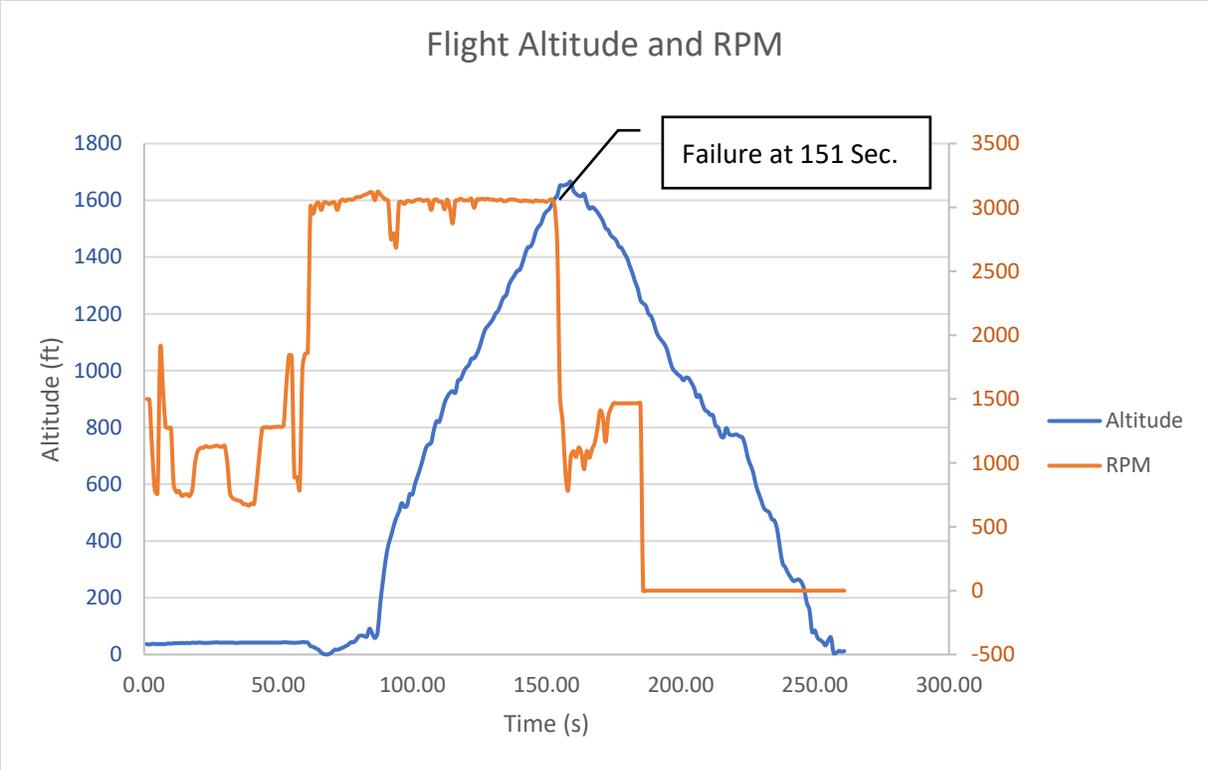
Figure 1. Flight Data recorded. RPM and Altitude

The MGL Enigma recorded the event, and the relevant data is plotted in Figures 1 through 4 below. Failure occurred at 151 seconds, and engine RPM, EGT's, CHT's, and oil temperature and pressure.

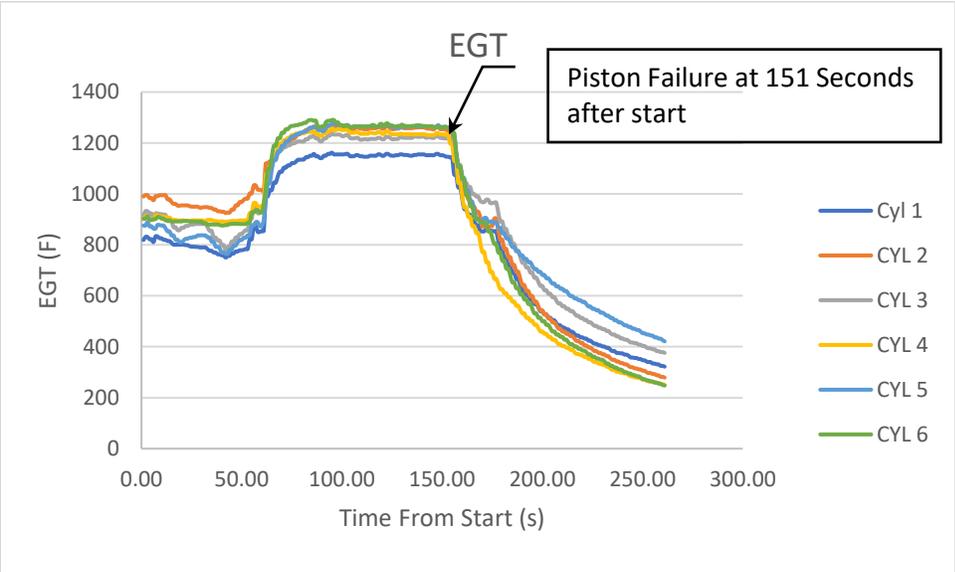
Figure 2. EGT during flight

In Figure 2, the reduction in EGT Temperatures corresponds to engine failure. This behavior is also apparent in Cylinder Head Temperatures.

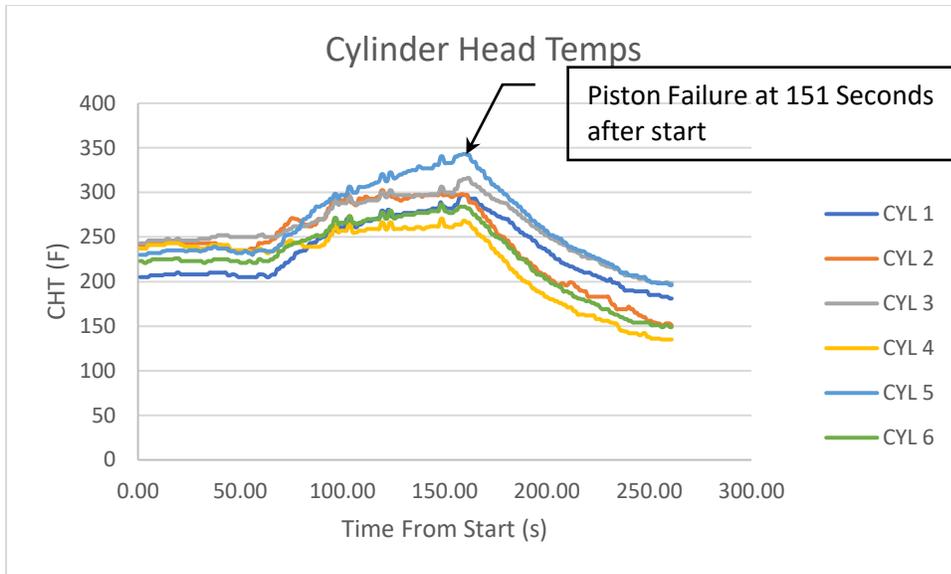
Figure 3. CHT

Figure 3 shows the CHT for all cylinders. Note the CHT for #4 dropping at almost the same time and rate as all cylinders after the failure.

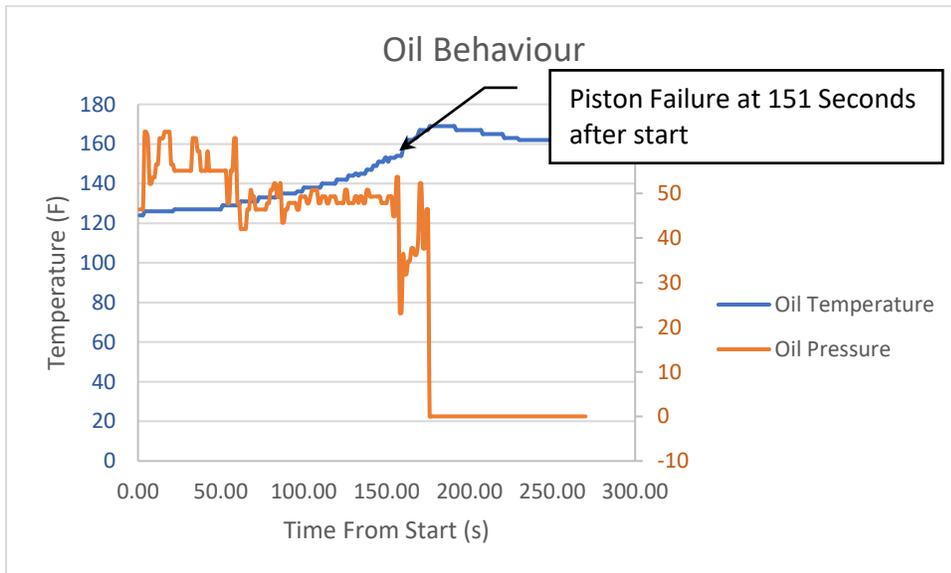
Figure 4 shows a continuing rise in oil temperature post failure, but the temperature is not excessive.

Figure 4. Oil temperature and pressure.

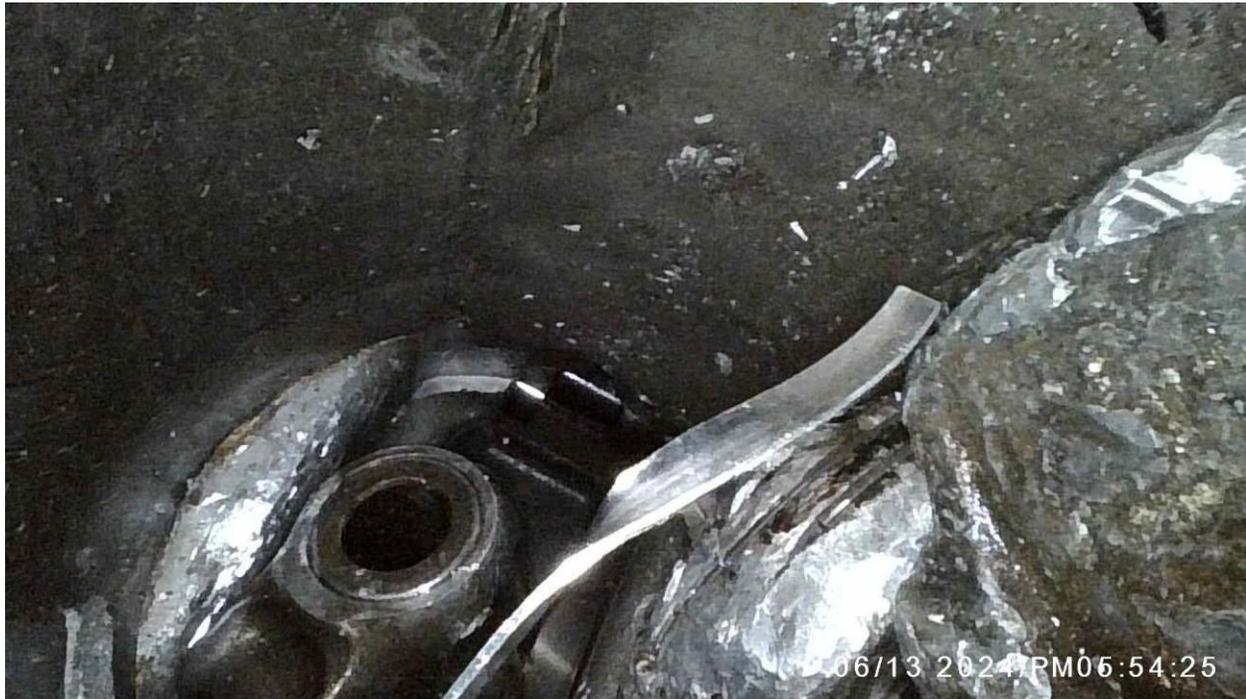
Post failure examination was done in hopes to find the root cause of the failure. Pictures were taken via a scope, and are presented below. It is clear that without the steel cylinders, the rod will destroy the surrounding architecture much more quickly. It is also clear that the valves did not fail, as both of them are in place. Without the engine continuing to run, as in the previous failure (thankfully), the piston did not reduce itself to aluminum granola.

*Figure 5. Bent over Rod and ring remains*

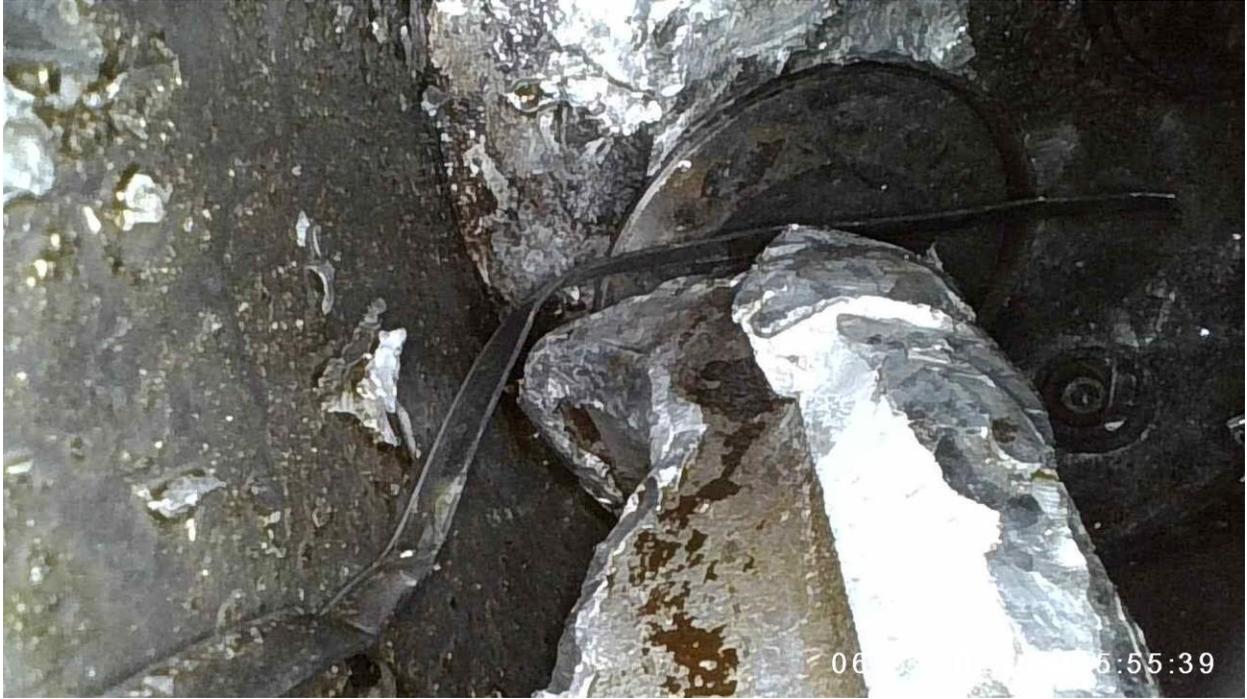
Figure 6. Valve with chunk of Piston

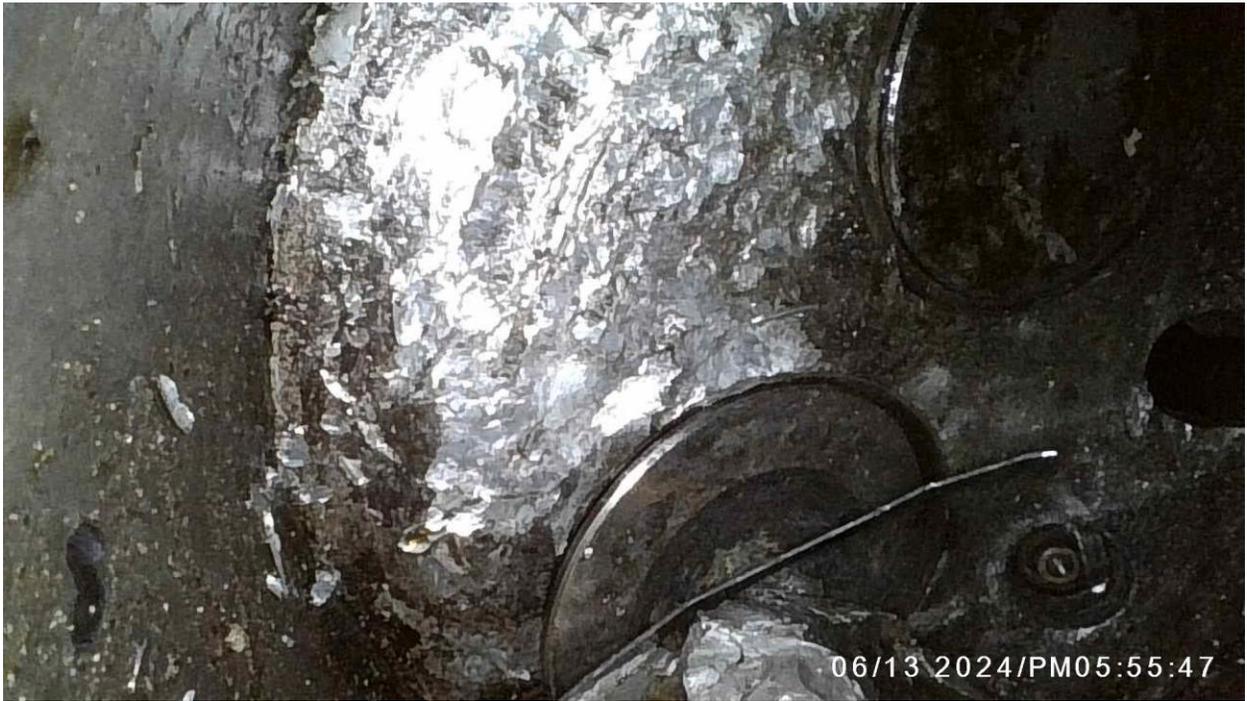
Figure 7. Both Valve are still in the head.

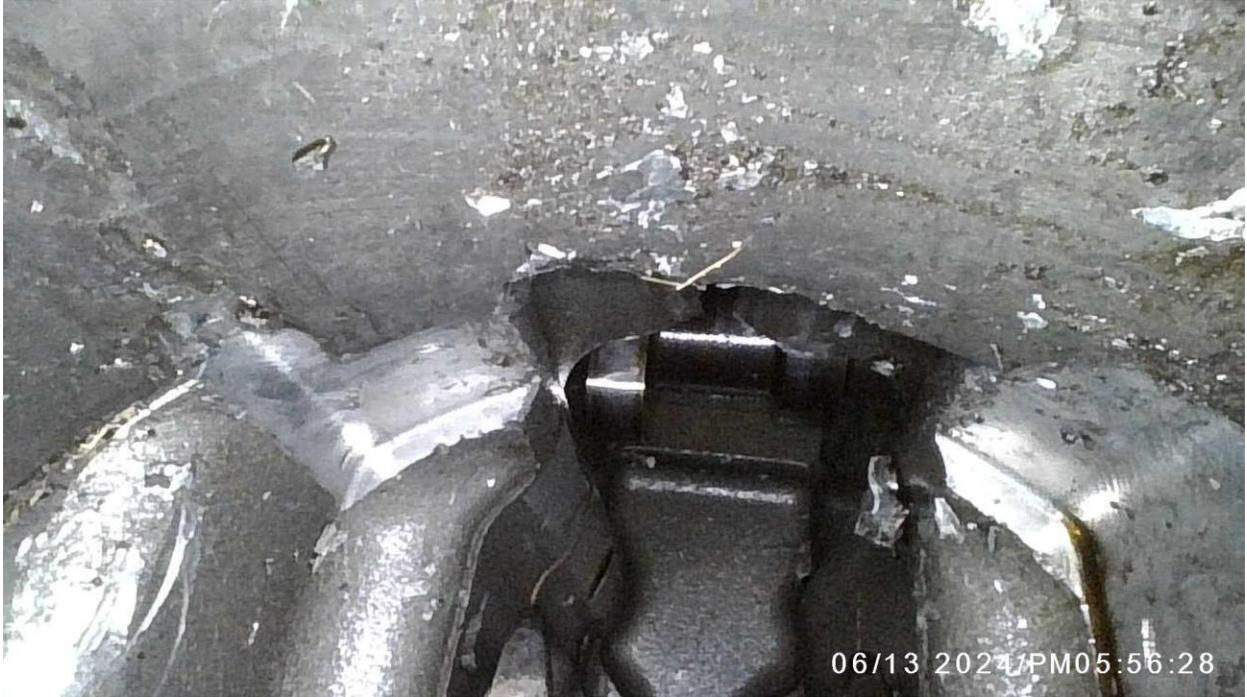
*Figure 8. Top of Cylinder at base.*

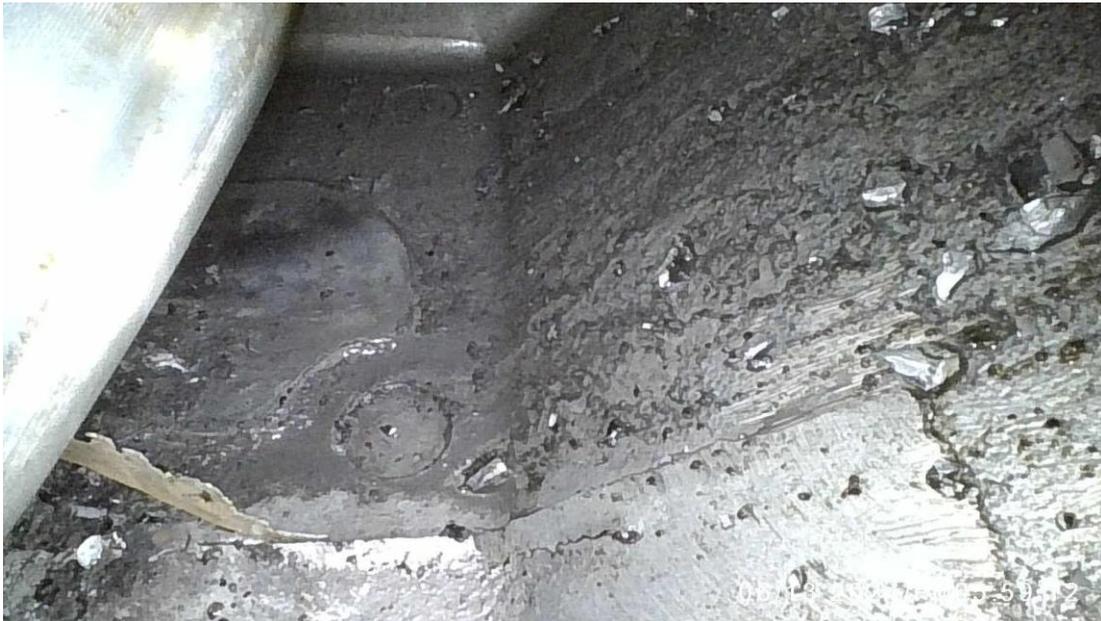
*Figure 9. In sump. Not as much "Granola". Probably due to shutting down the engine quickly.*

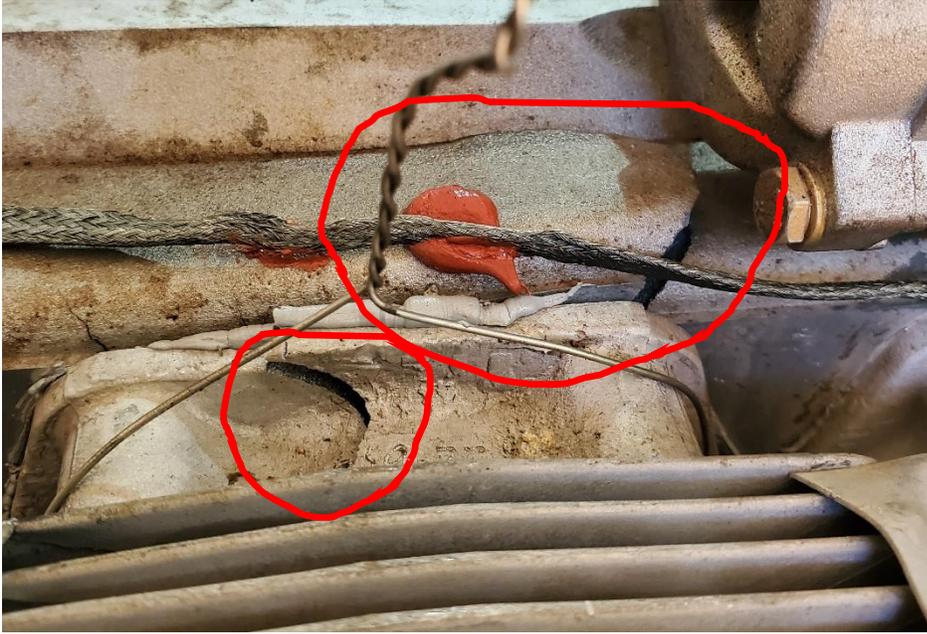
Figure 10. Outside, top of engine, looking at #4.. Note large cracks.

I elected not to open the engine beyond scoping through the spark plug holes. Instead, I took it to Arion Aircraft to let them look through it. It was discussed the engine was not likely rebuildable, but since it stopped so quickly that damage to remaining cylinders was not likely. The case is not usable, but the remainder, sans the cylinder and associated rod appear OK.
