Propeller loss on a Sonex

By Robert E. Barber

Builder/Pilot of Sexy Hexy (N157SX)

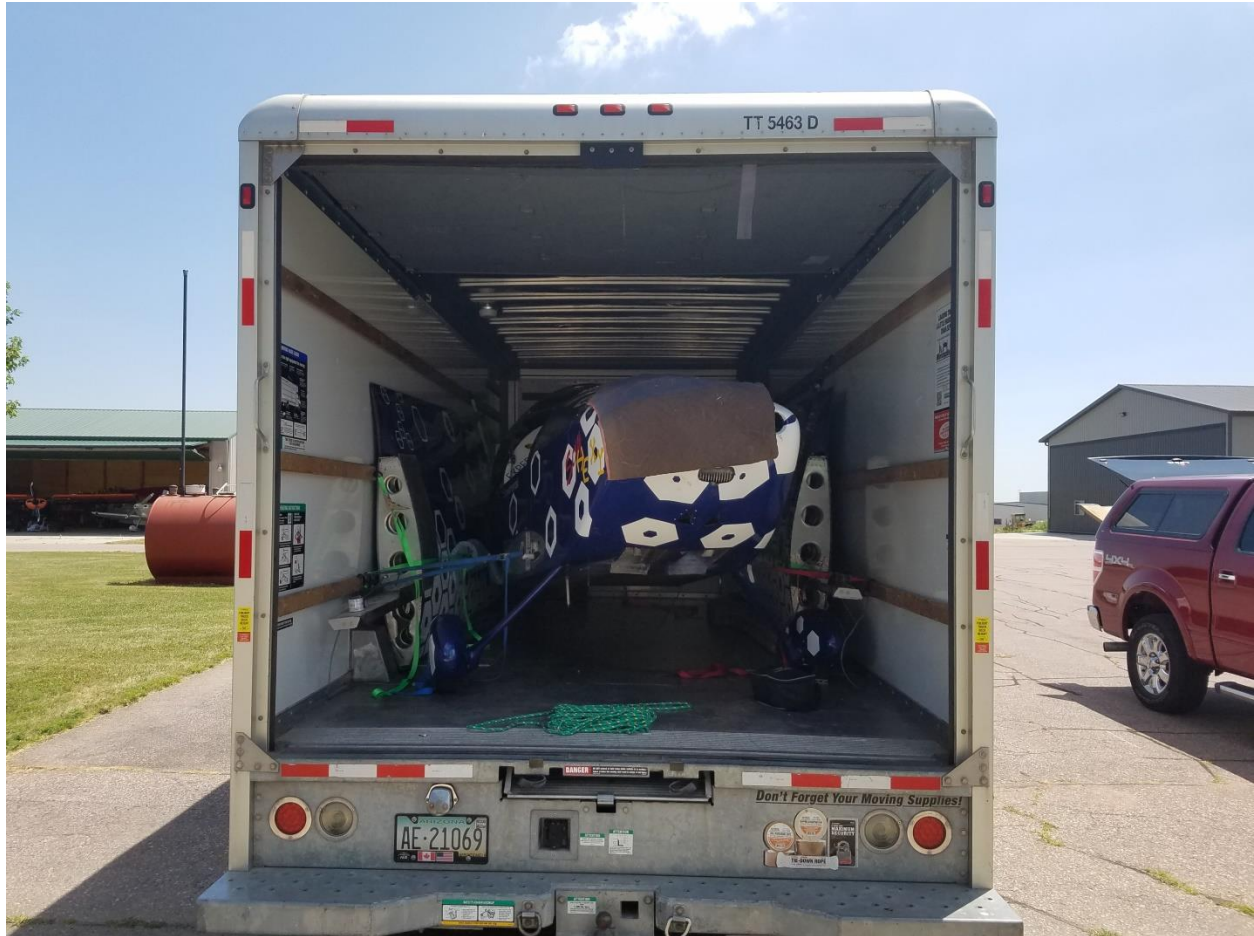
Figure 2. I had about 2" to spare. If the propeller was still attached, the tailcone would have to be stuck up in the "attic" to fit. Horizontal Stabilizer would not quite fit through the door.
